CLASSIFICATION REPORT LOADBEARING WALL

Name of sponsor:	Realdania By og Byg A/S		
Product name:	Loadbearing wall		
File no.:	PCA10972A	Revision No:	0
Date:	10-07-2024		
Pages:	6	Encl.:	NA
Ref:	CHD	/	CHB

TEST REPORT LOADBEARING WALL

Name of sponsor:	Realdania By og Byg A/S		
Product name:	Loadbearing wall		
File no.:	PGA12453A	Revision no.:	1
Test date:	15-02-2024	Date:	04-07-2024
Pages:	9	Encl.:	35
Ref:	MMN	/	CHB

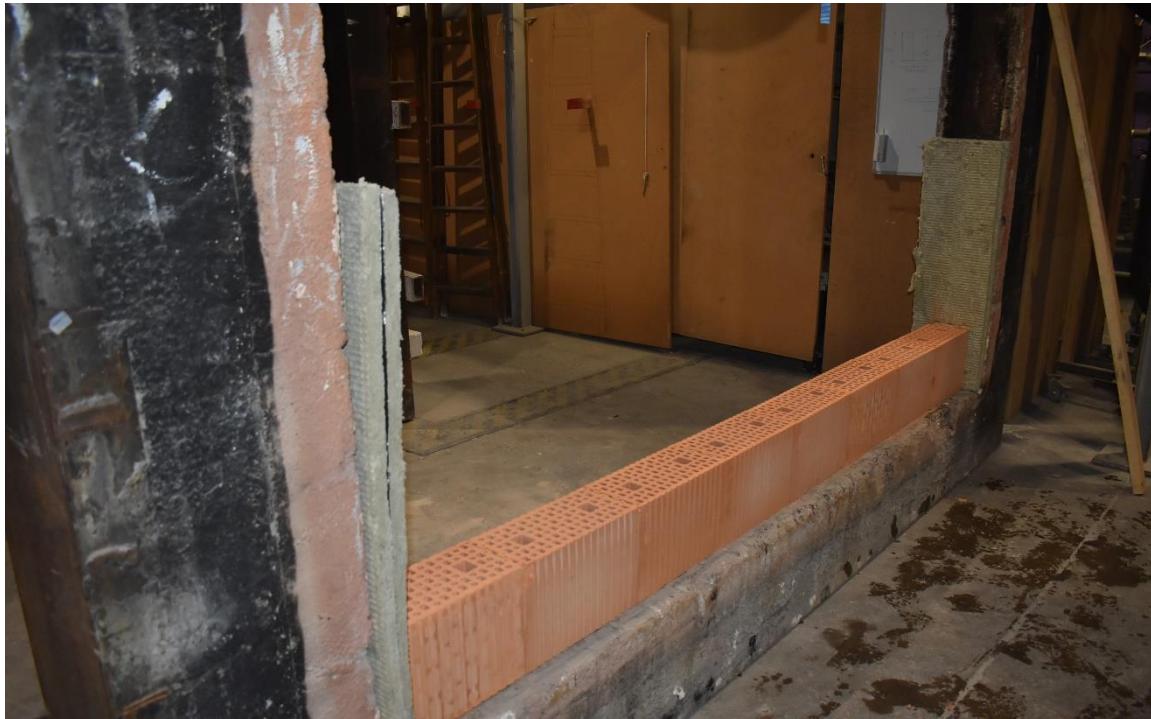
Photo No. 1 Mounting of the first layer in the bottom of the wall.

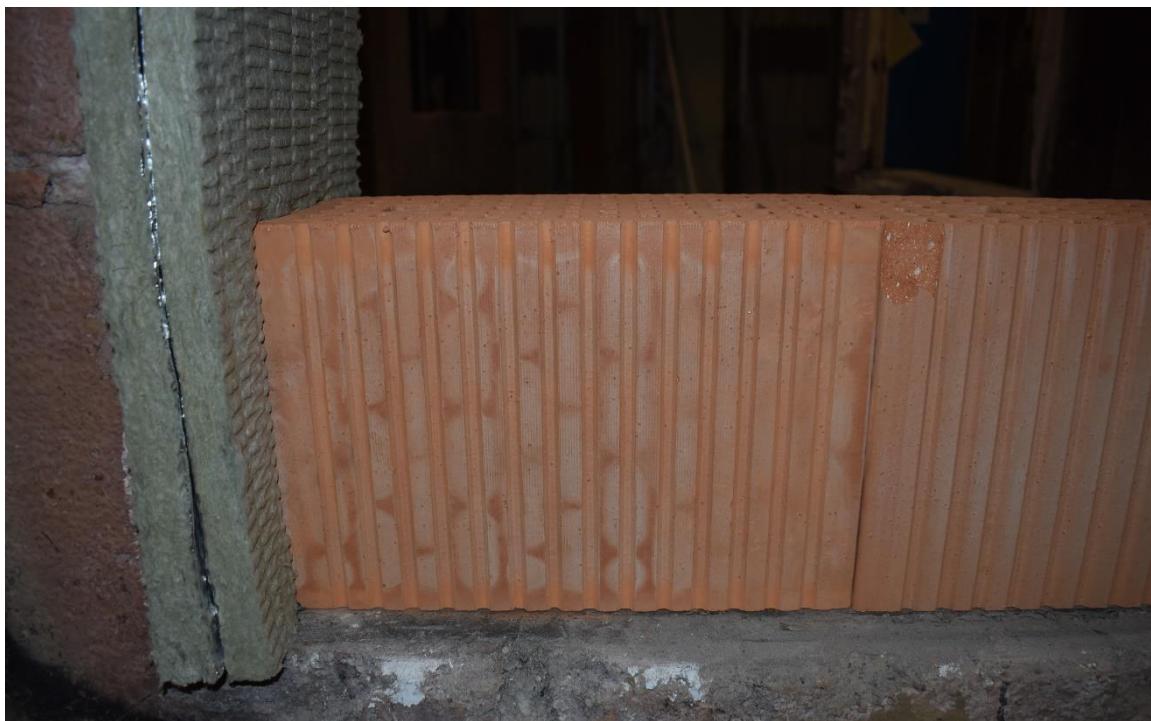
Photo No. 2 Close up on the block from the bottom layer.

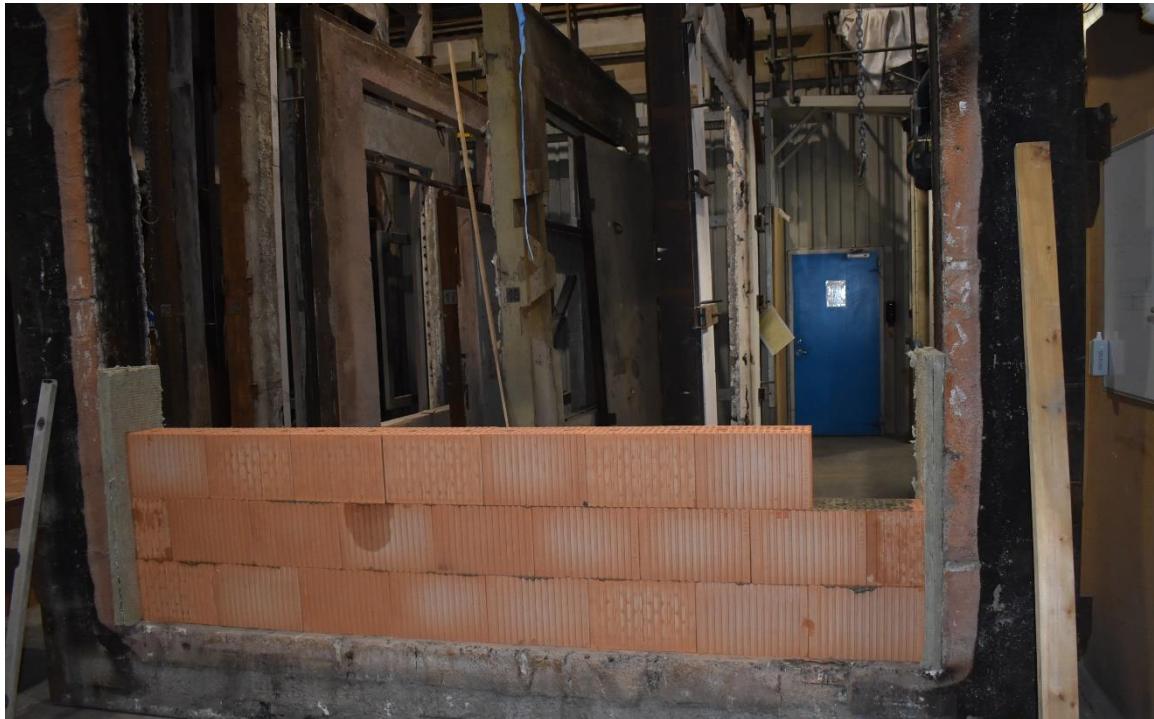
Photo No. 3 Three layers of the wall mounted to the bottom.

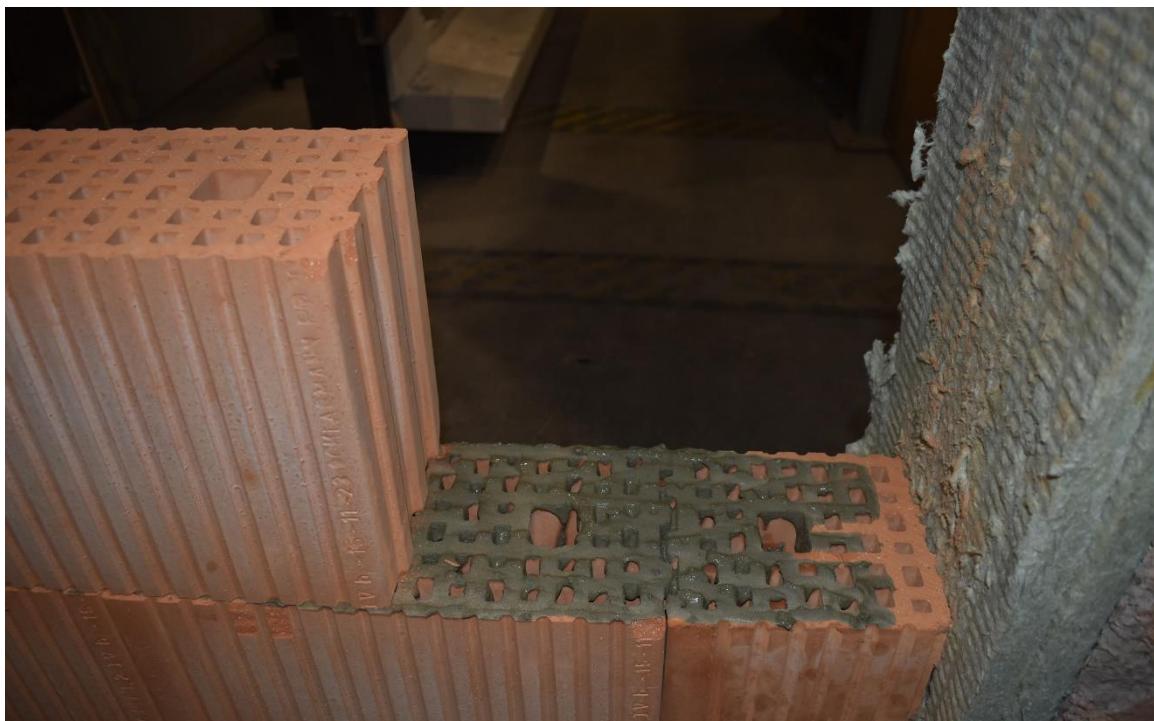
Photo No. 4 Mortar on top of the blocks for placing the next layer of blocks.

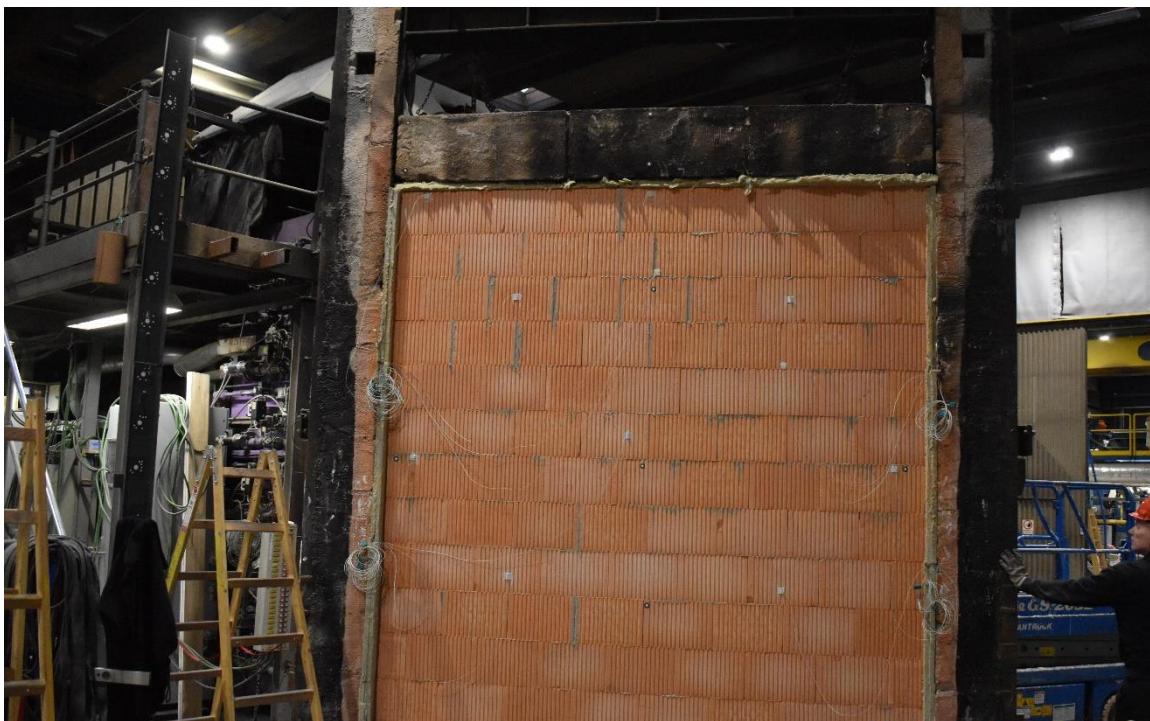
Photo No. 6 Wall drying with thermocouples mounted to it.

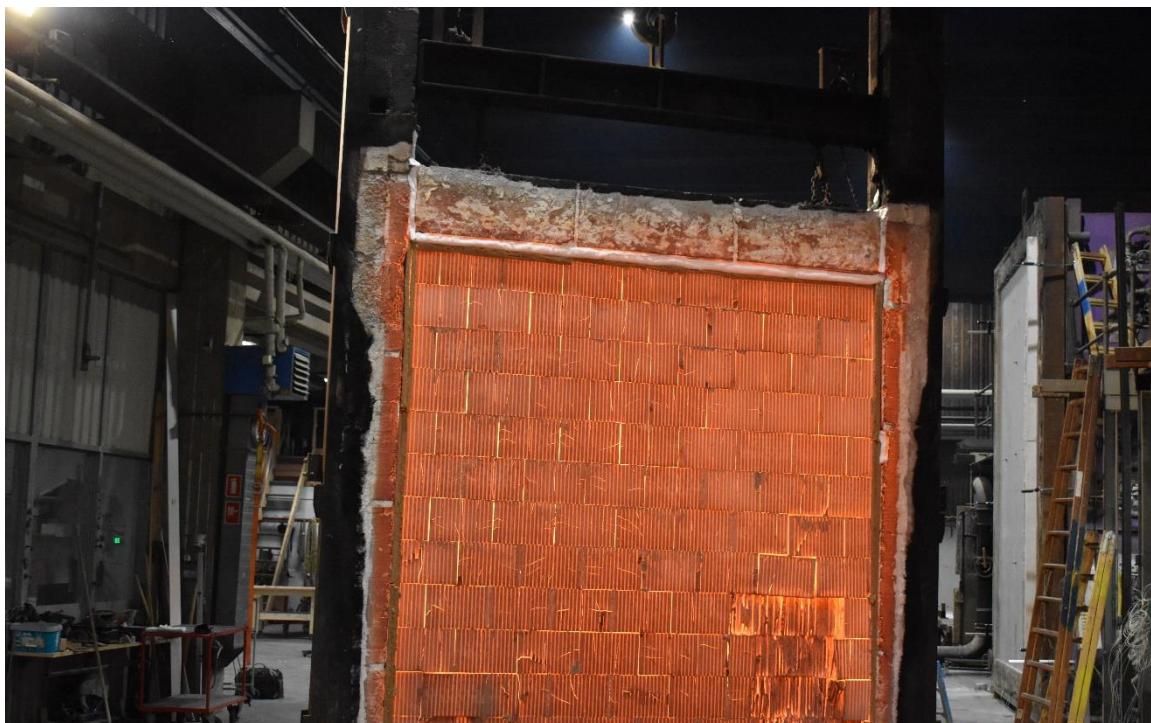
Photo No. 13 Blocks was glowing red from the heat.

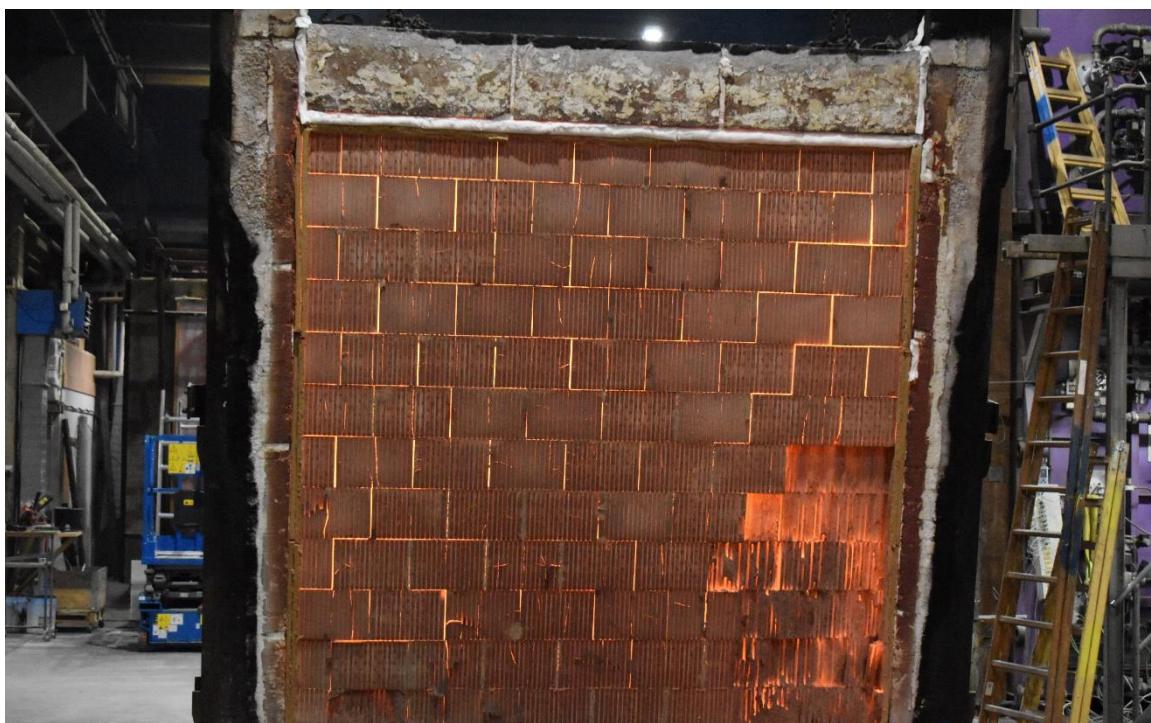
Photo No. 14 Blocks are whitened after the heat reduces.

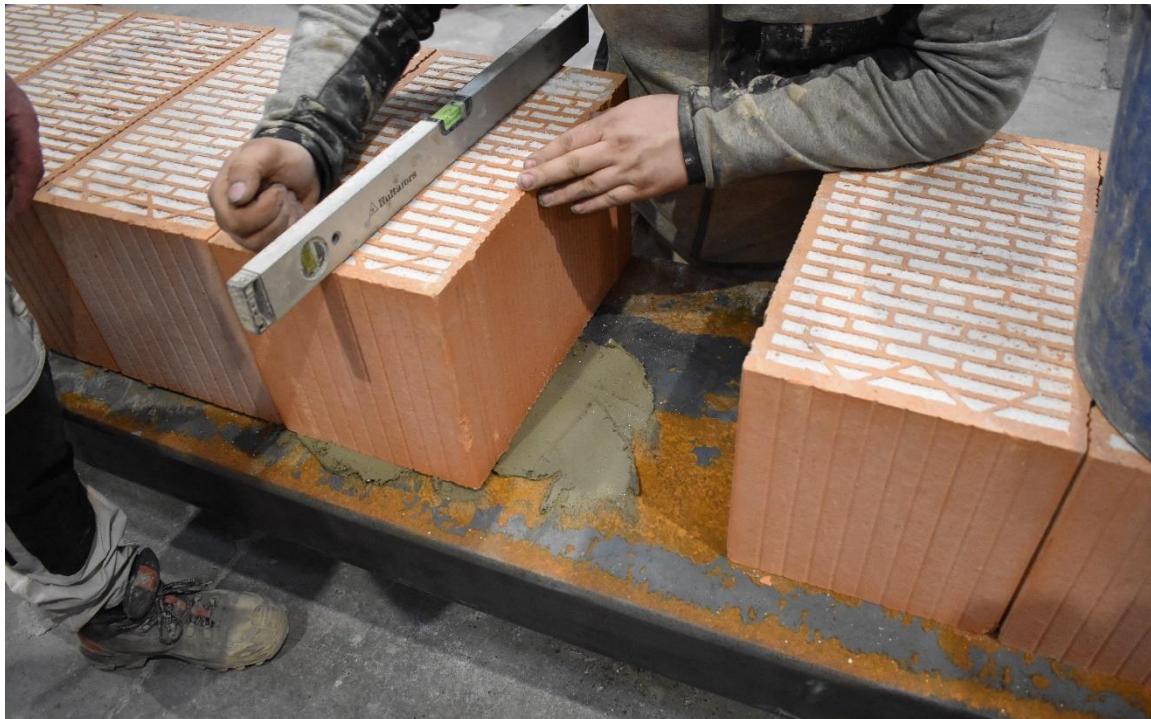
Photo No. 3 The blocks were aligned before placing the next layer

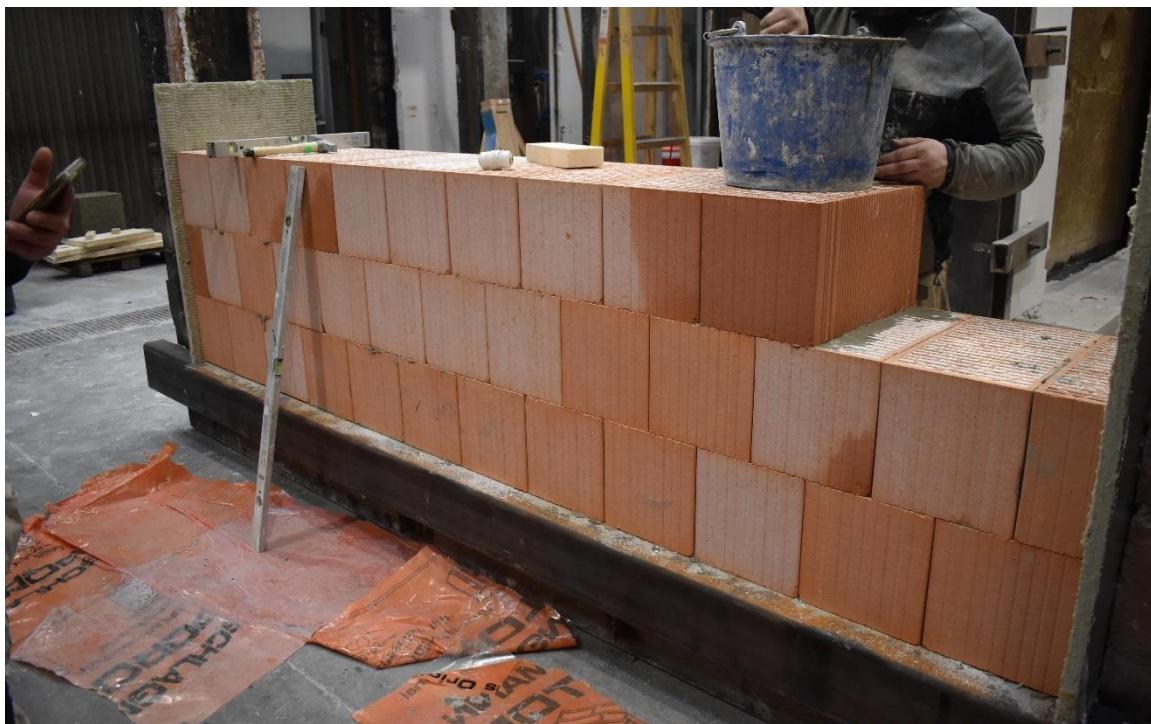
Photo No. 4 Three layers was placed with mortar on top of them

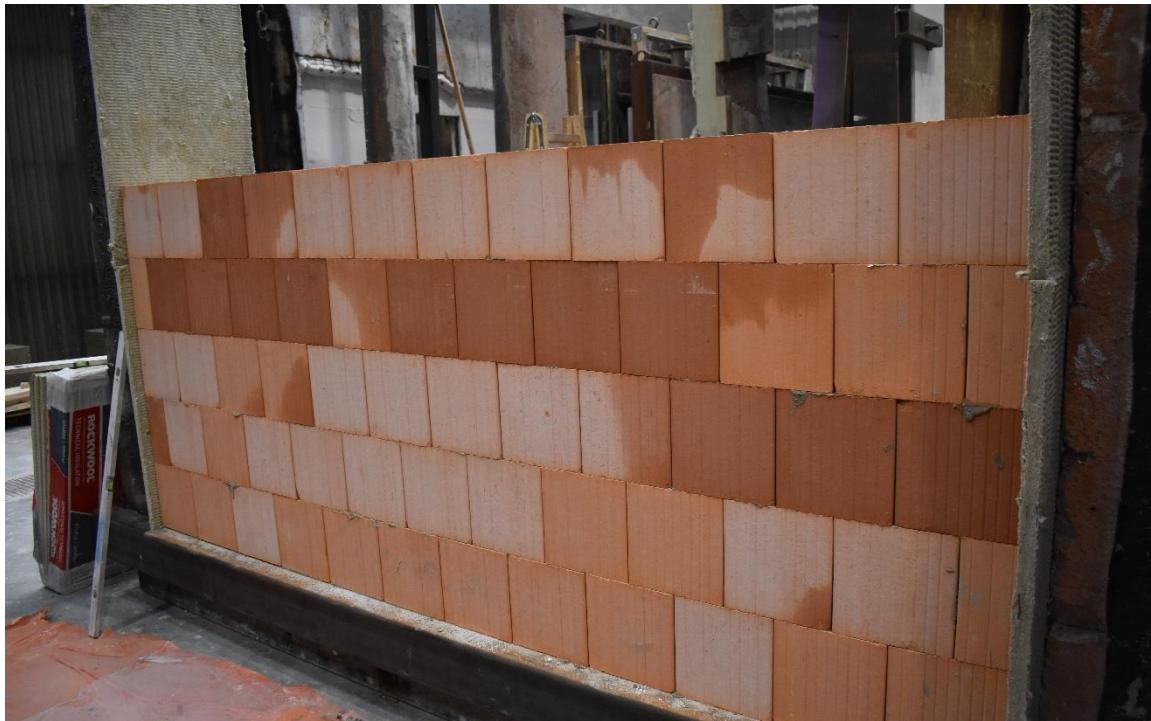
Photo No. 7 Continuation of the wall where mortar in the joints are visible

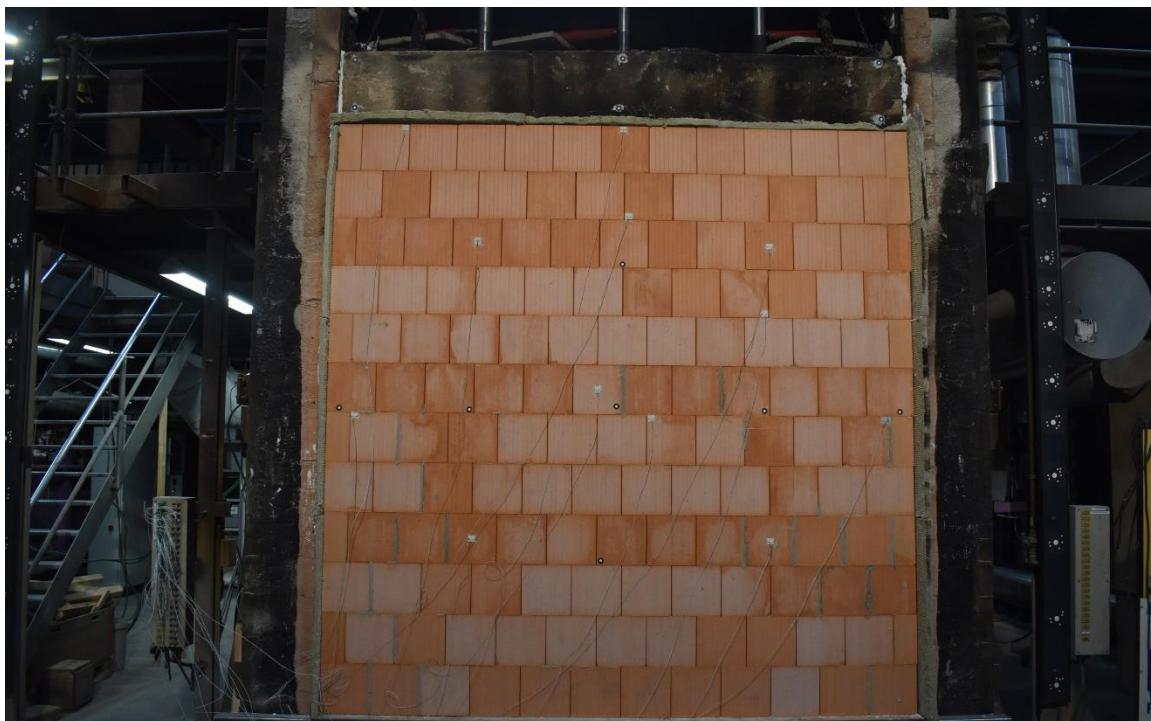
Photo No. 12 Thermocouples mounted on the wall

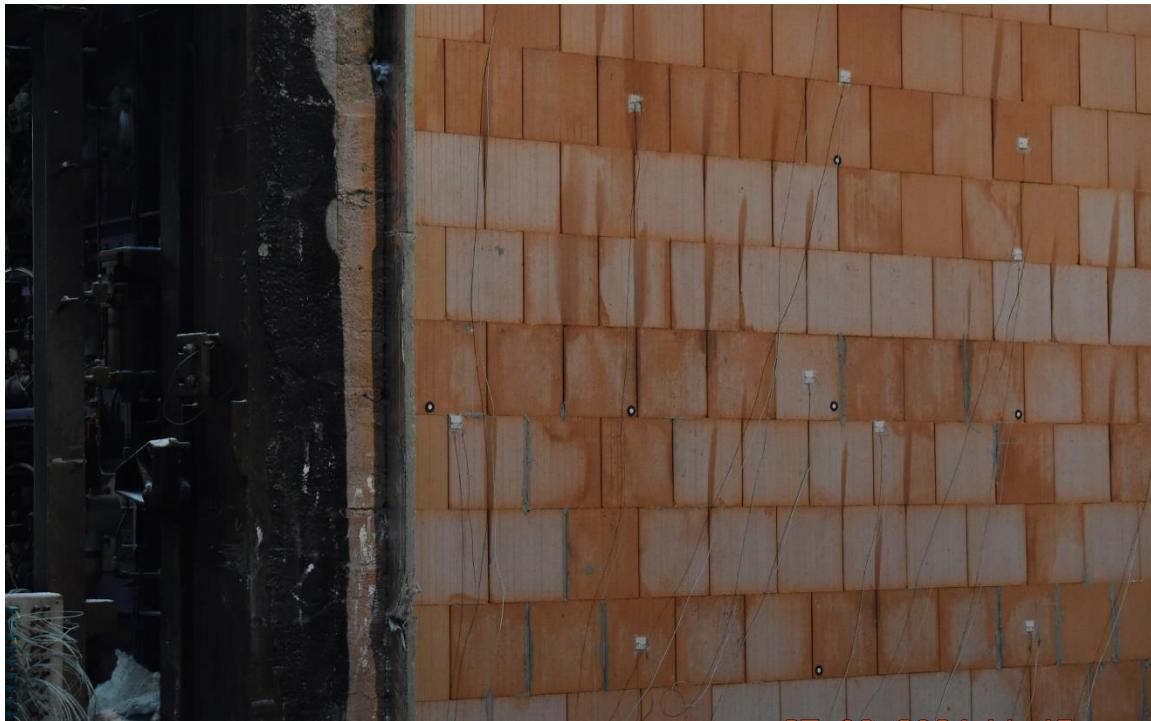
Photo No. 17 163 minutes in the test, with visible moisture from the joints
